April 9, 2024

## **Student Affairs ERM Risk Response Plans for Division Facilities**

### ***Addendum: Facility Photos and Risk Factors***

#### **TURNER STUDENT SERVICES BUILDING AND ARCADE BUILDING**

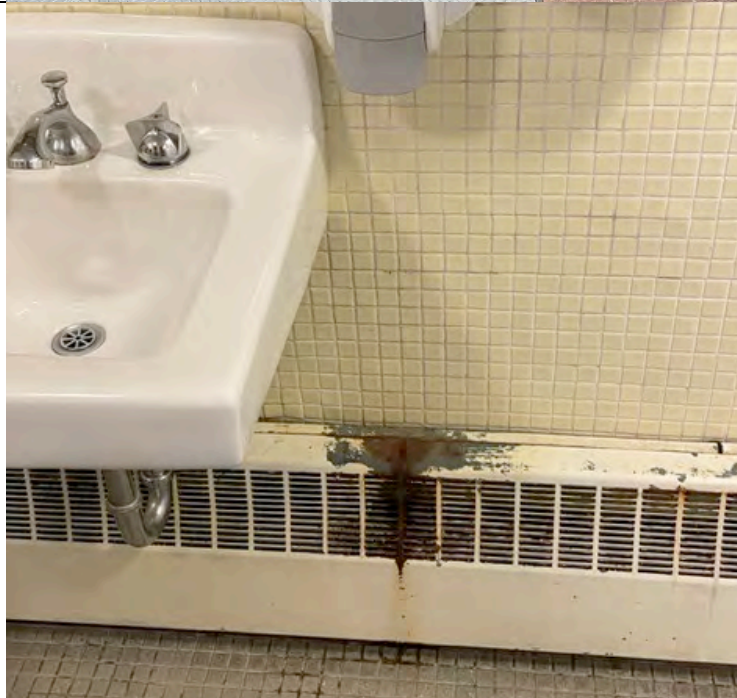
**Building:** The second-floor women's restroom has rust on the heating element from years of water and soap dripping on it, which is not only an eye sore, but also a potential hazard.

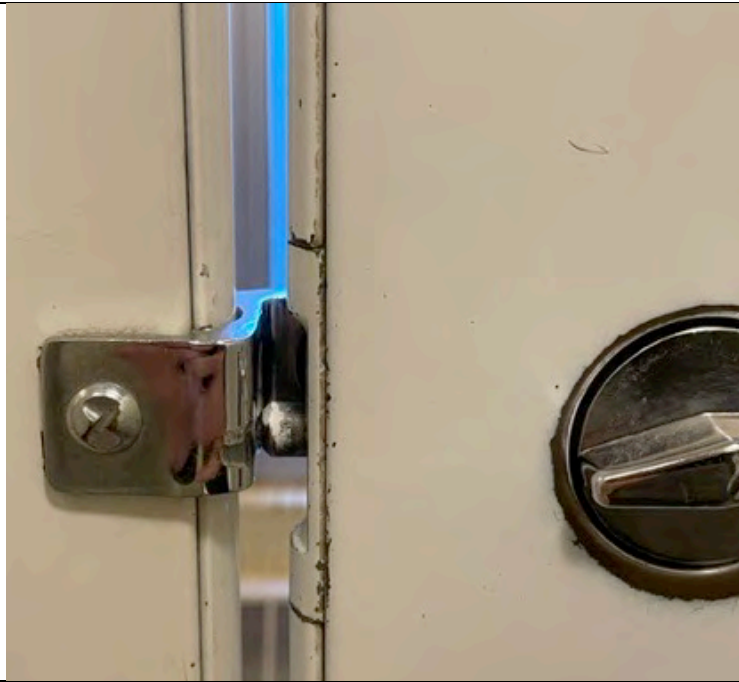
**Building:** The smaller stall in the first-floor women's restroom doesn't securely lock. (Note the locking pin comes out, but it does not touch the stall frame because the gap is too large.)

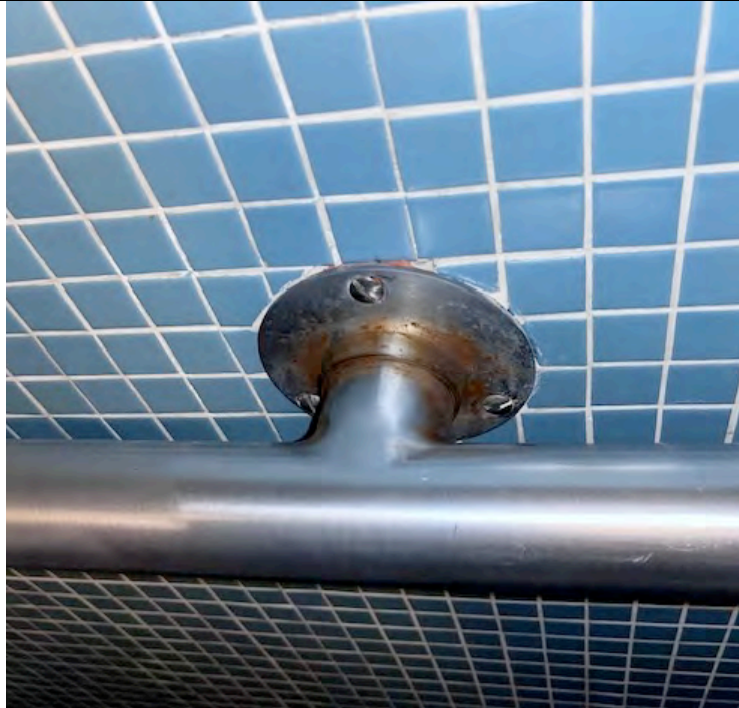
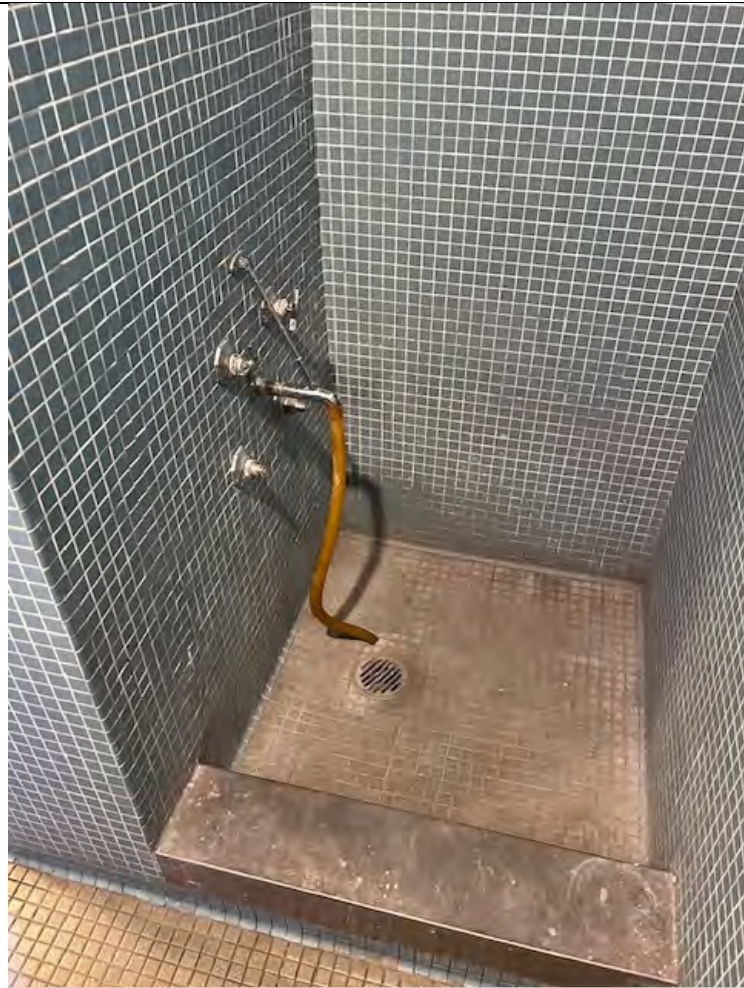
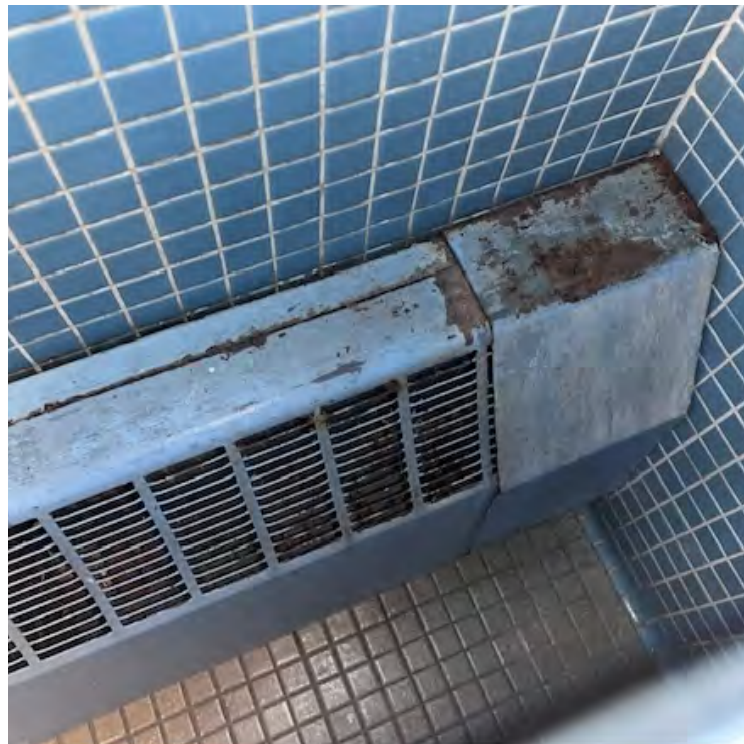
**Building:** Bathrooms have rusty fittings for grab bars, rusty heat registers, etcetera. A bucket filling station and drain is the first thing one sees when entering the bathrooms.

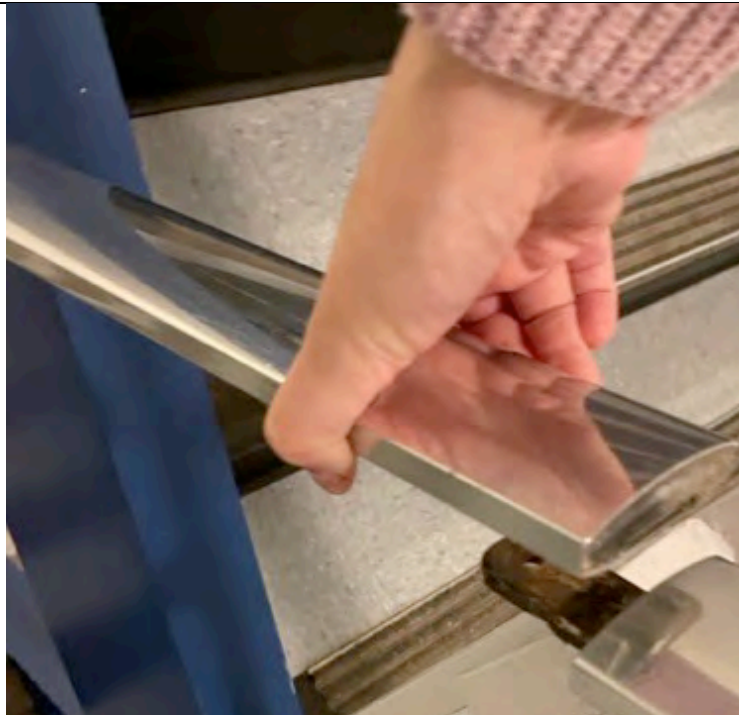
**Building:** The handle of the first-floor landing stairwell comes detached easily which can be hazardous, especially for those who may need added support in the stairwell.

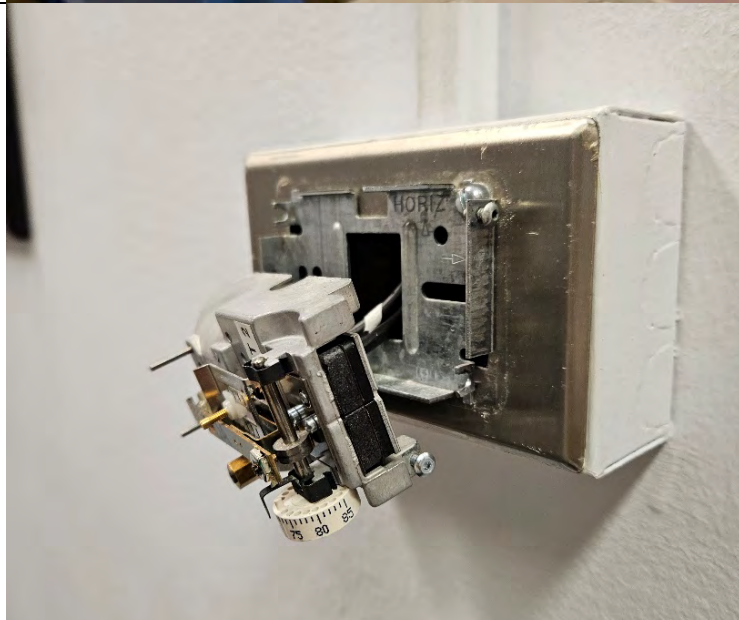
**Building:** In the Counseling Center, there is an unhinged/broken thermostat, the temperature cannot be changed. It displays 70 degrees Fahrenheit, but it feels like 80 degrees Fahrenheit in the room. It is also an electrical hazard.

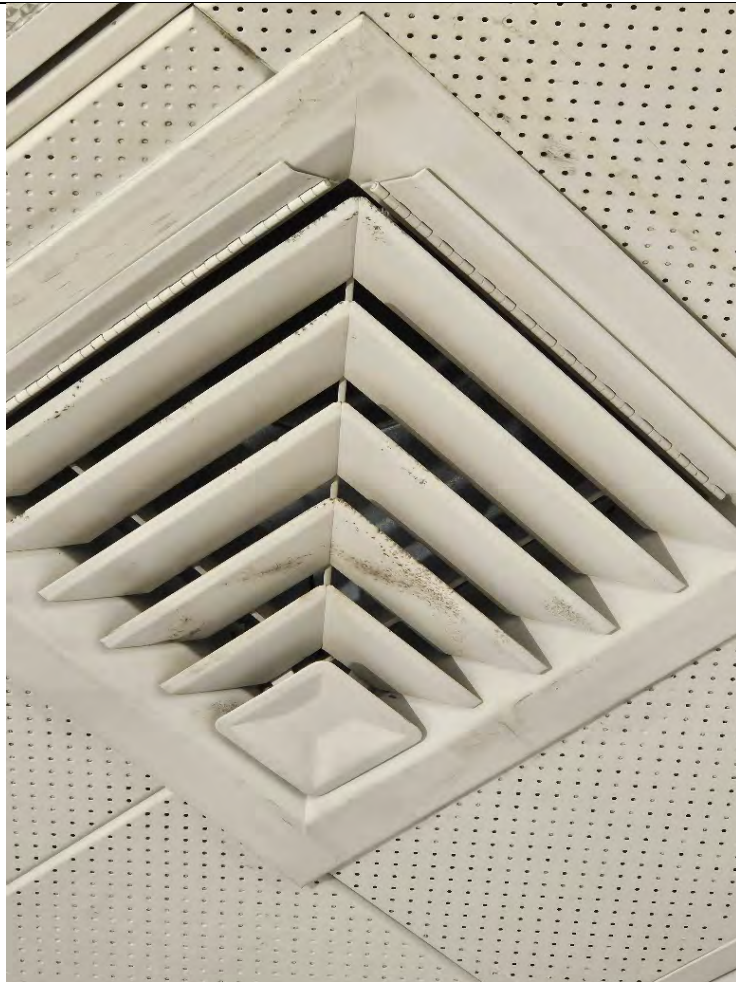
**Building:** It appears air vents are rarely cleaned.

*From an employee in the Counseling Center: Being highly prone to dust and pollen allergies and having asthma, I am impacted daily by the lack of clean filtration in the building. Many of my clients are also impacted. I am cleaning a lot of dust in my office every other day. Even with an air purifier it is difficult to keep my space clean and safe for myself and my clients with similar health conditions. Pictured is the employee's air vent in office 234.*

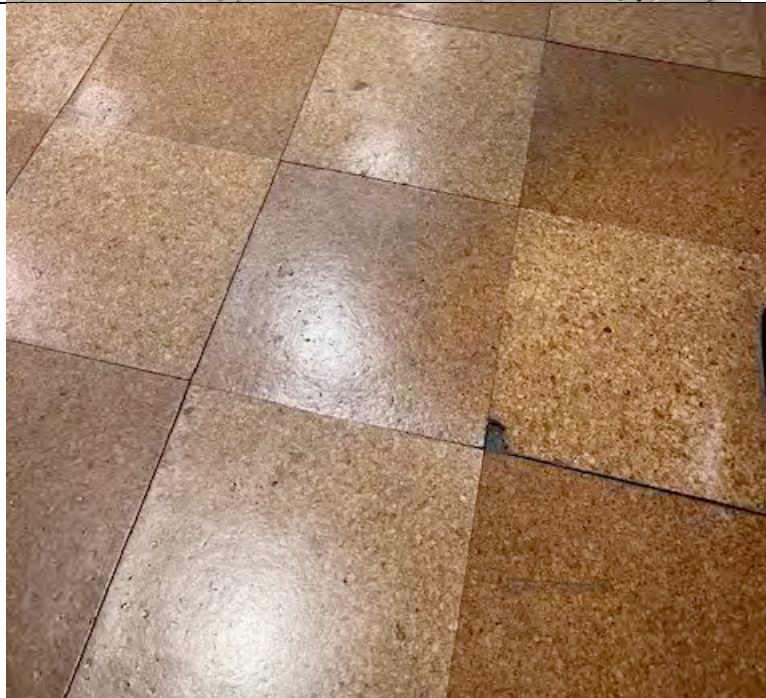
**Building:** Cracked tile.

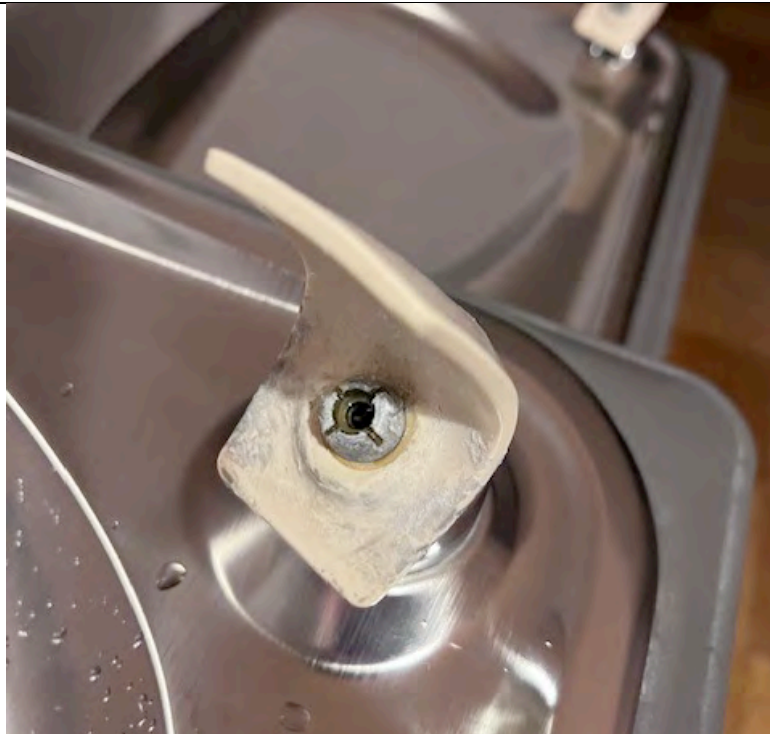
**Turner Student Services**  
**Building:** Aging water  
fountains.

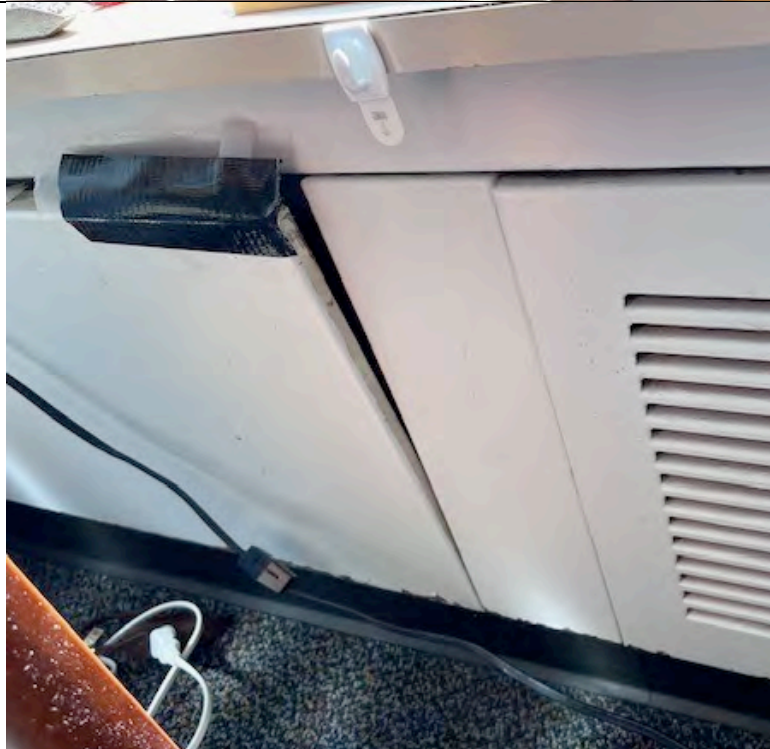
**Turner Student Services**  
**Building:** Radiators in the  
counseling center offices are  
no longer in service. They are  
falling apart and rusting.

Additionally, each of the  
counseling center offices  
has only one or two electrical  
outlets, requiring the use of  
multiple power strips and/or  
extension cords.

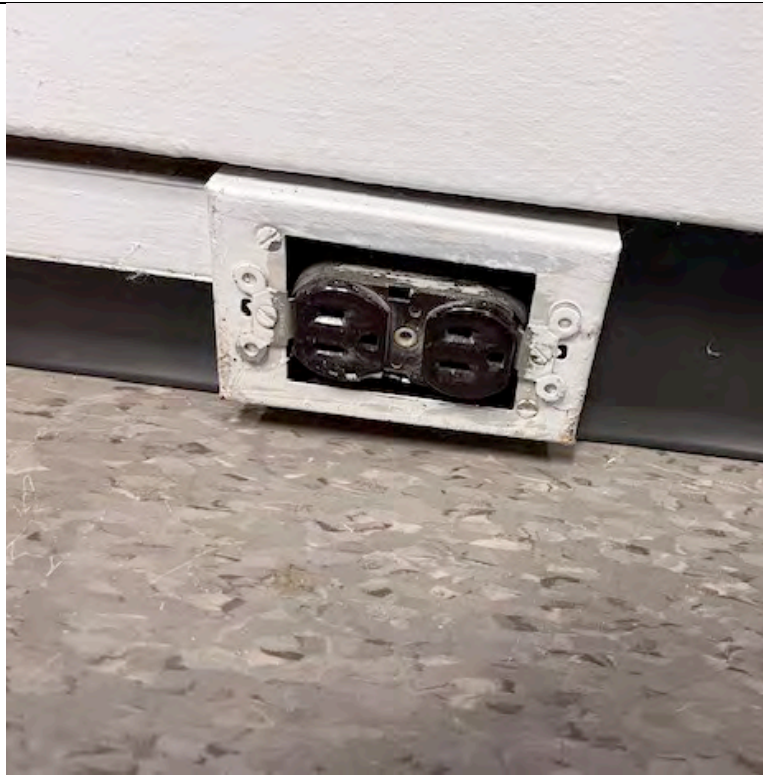
**Turner Student Services**  
**Building:** Rusty, exposed  
electrical socket.

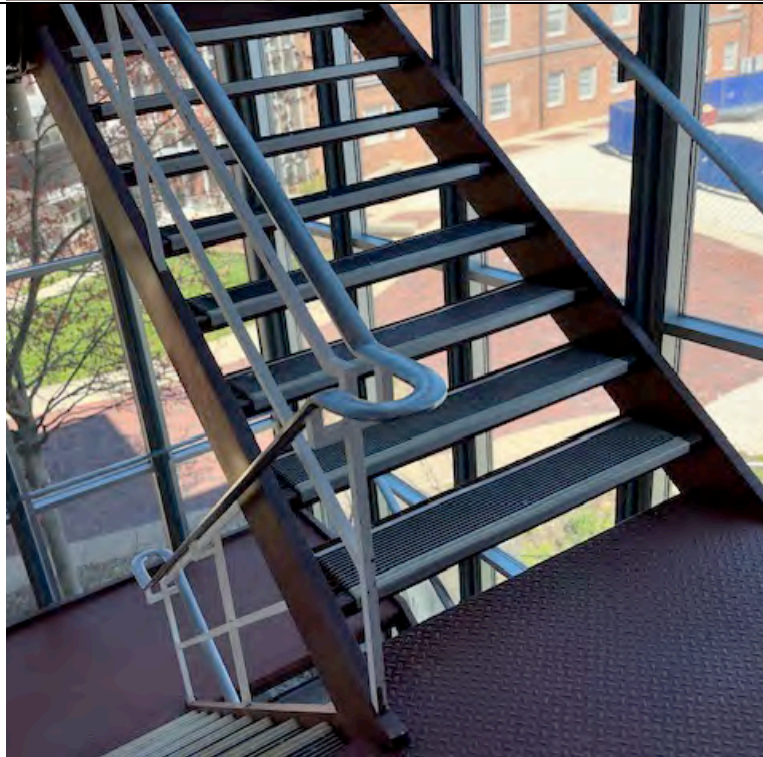
**Turner Student Services**  
**Building:** The emergency  
egress stairwell metal deck  
flexes when stepped on and  
makes a loud banging noise.

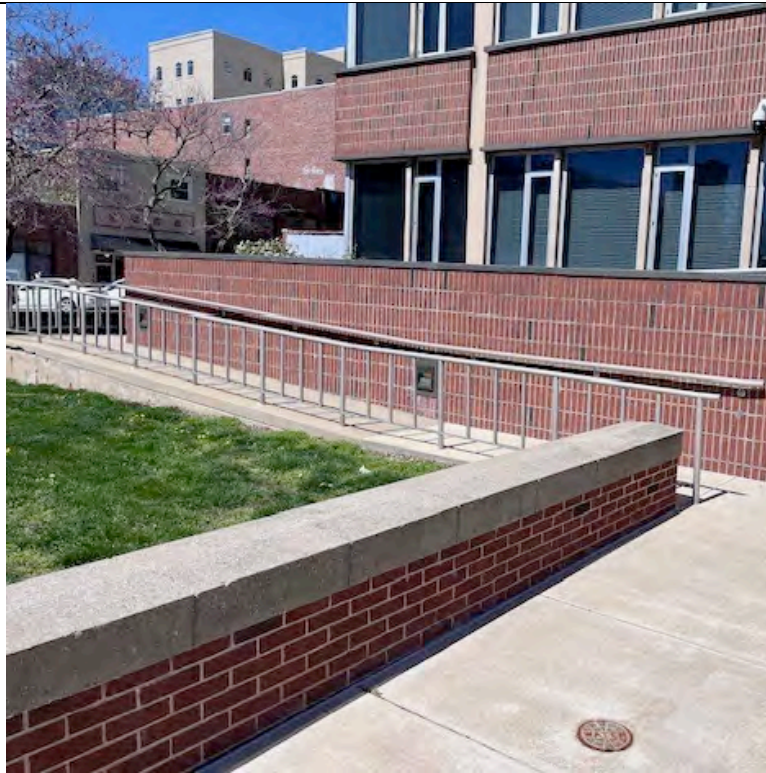
**Building:** Exterior building ramp is very narrow making it difficult for wheelchairs and wagons to traverse it with ease.

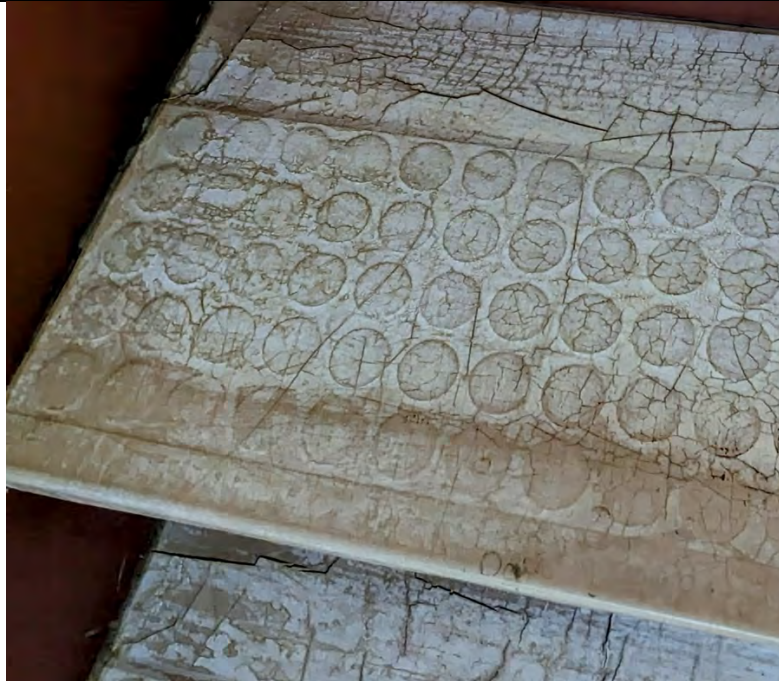
**Arcade Building:** Cracked flooring in stairwell

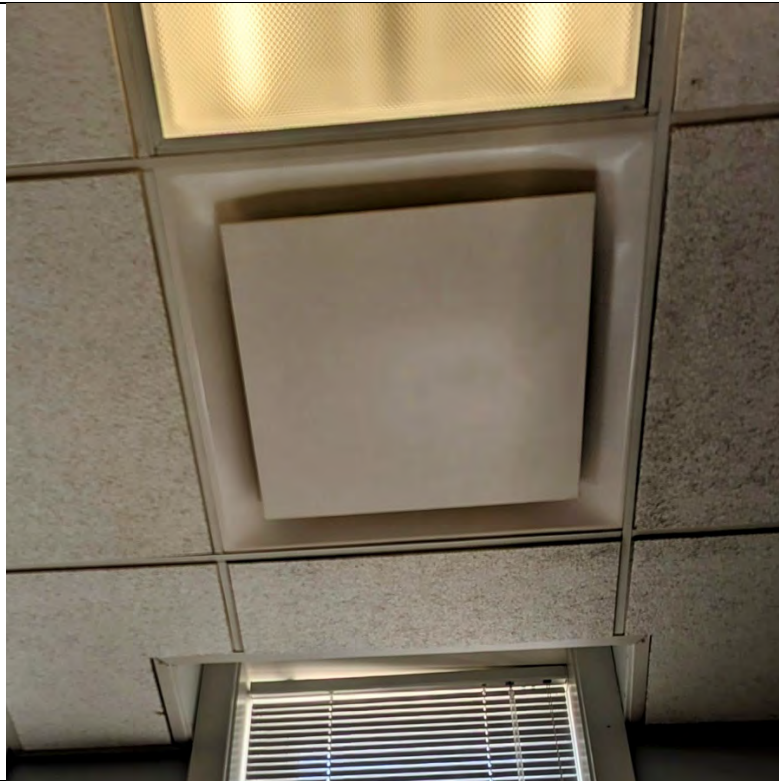
**Arcade Building:** Air vent – the HVAC system and air handlers have not functioned appropriately for more than 10 years; there has been an immense amount of time and expense trying to make the air handlers function without any improvement in reliability.

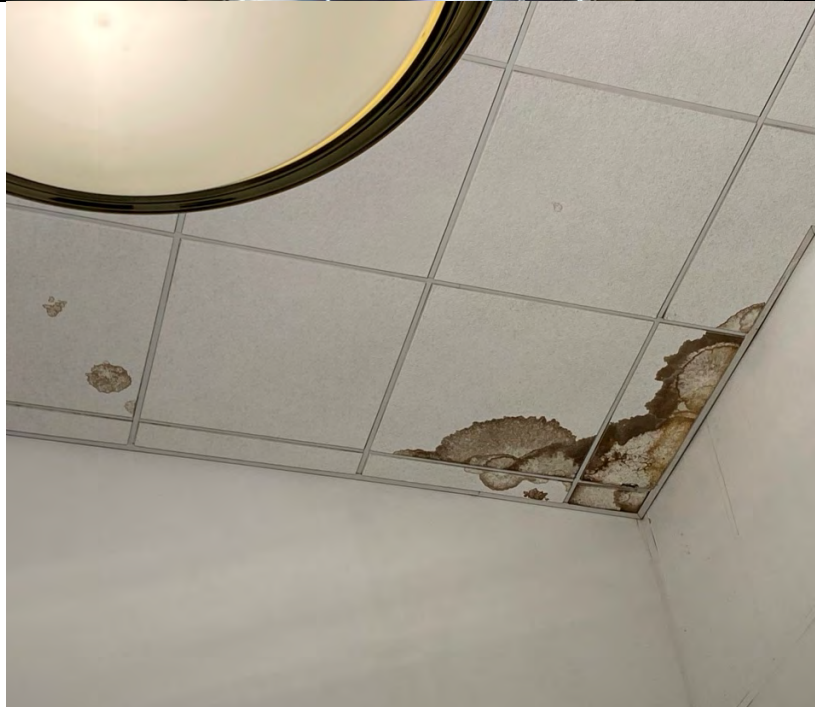
**Arcade Building:** There is water damage in the small conference room and a couple of offices. The roof has been leaking for a long time, but we haven't been able to get the roof replaced for reasons beyond our control (see additional roof damage photos in this table, below).

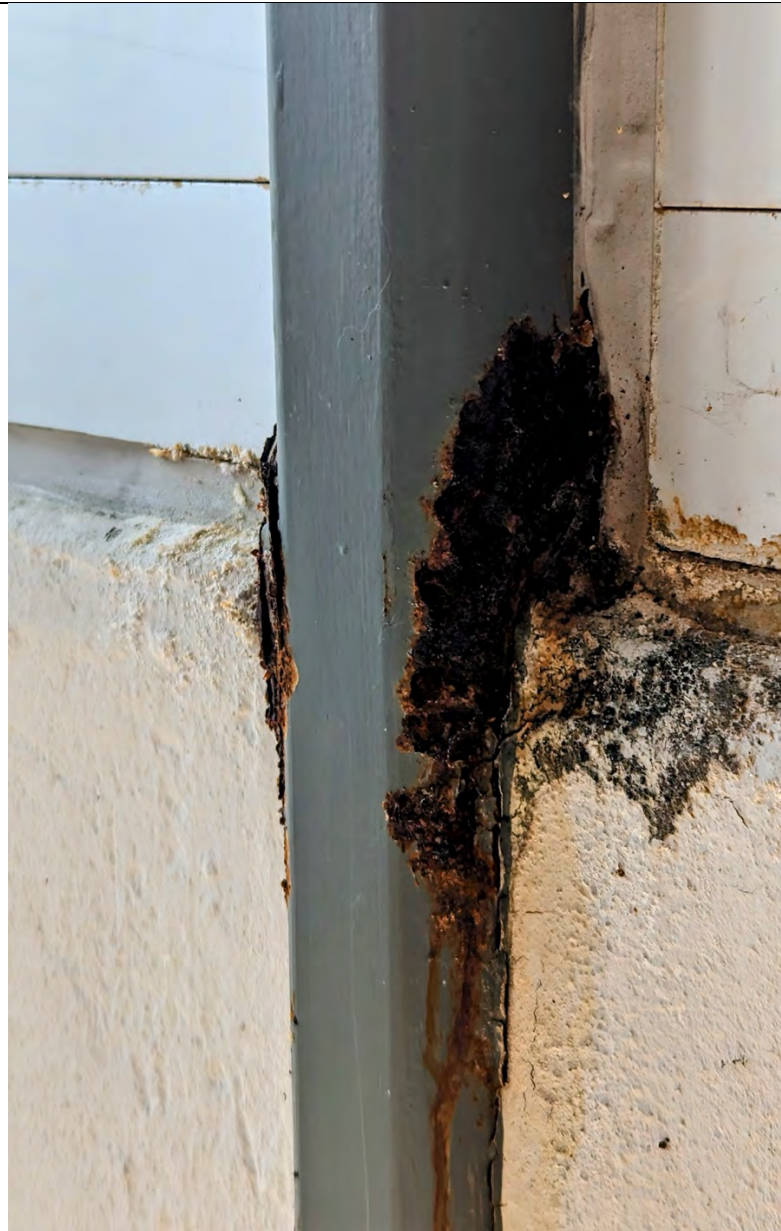
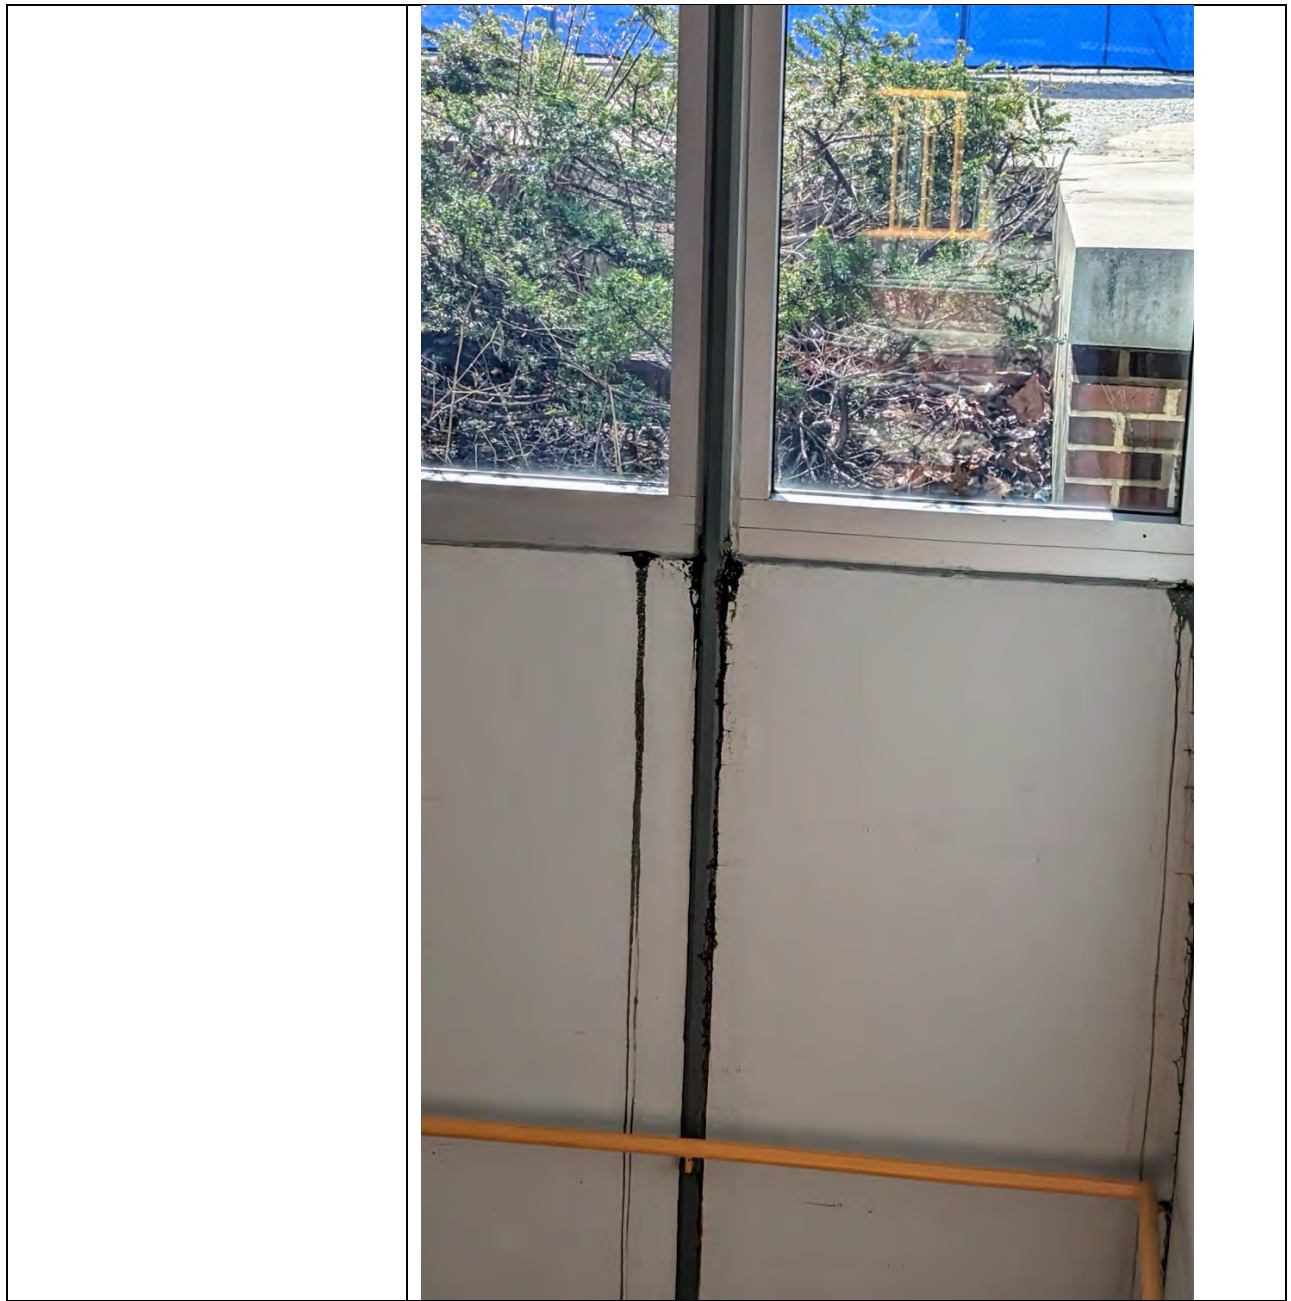
**Arcade Building:** Steel upright beams that are part of the structure for the stairwell. These beams are corroding at ground level.

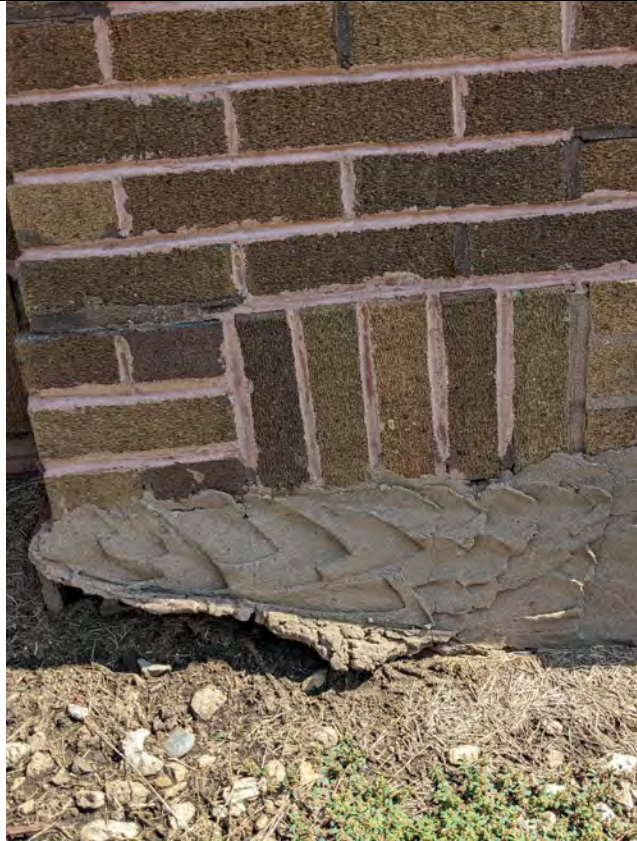
Crumbling foundation

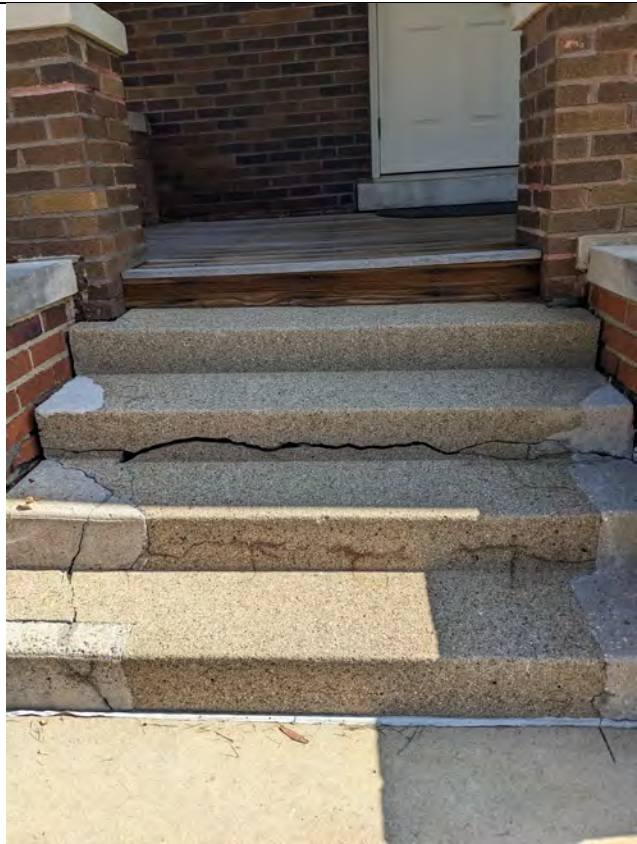
**Cracked stairs**

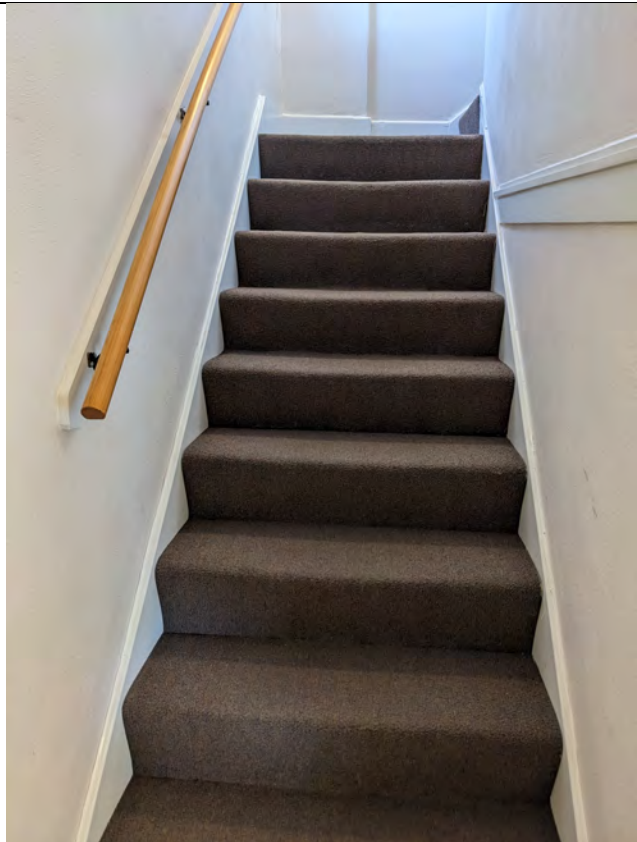
**Inaccessible stairway to second floor, no elevator**

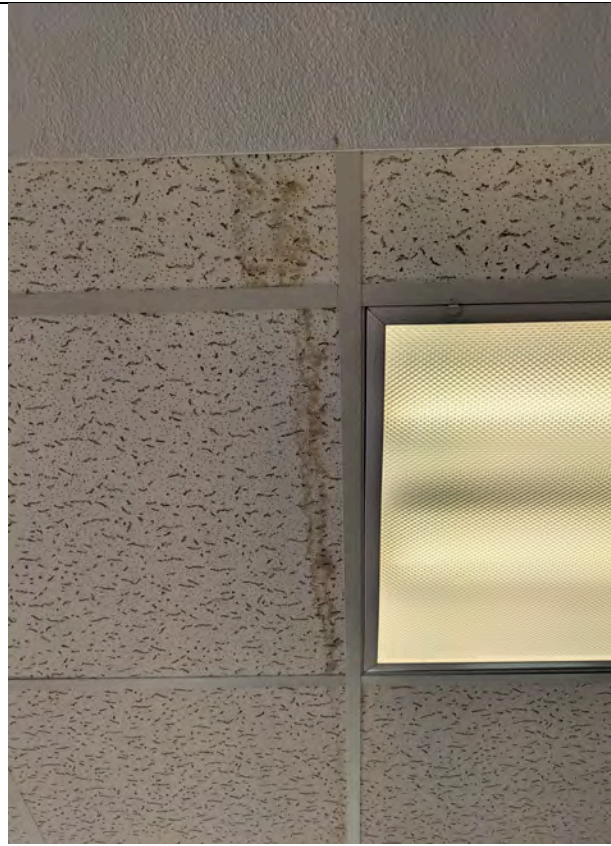
Roof leaking water onto interior ceiling

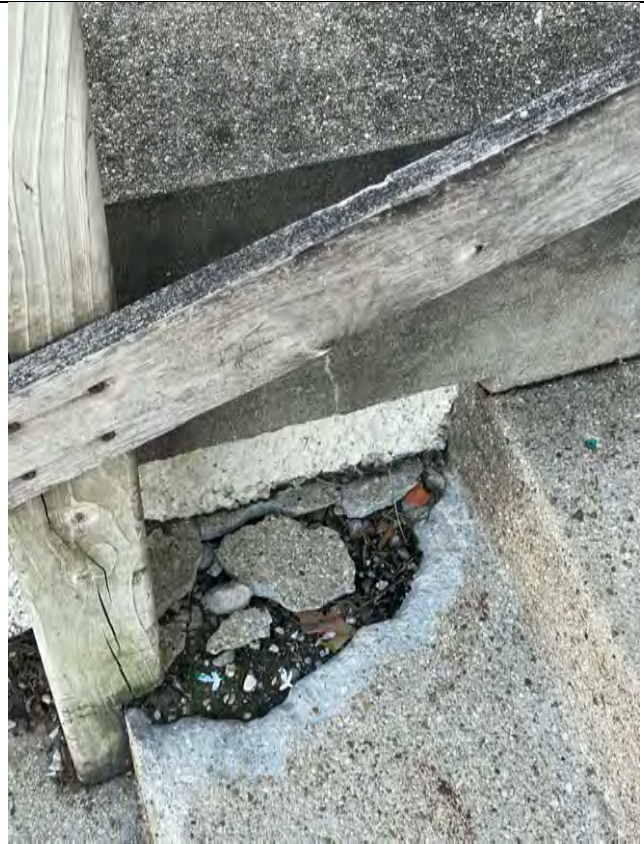
Crumbling exterior stairs

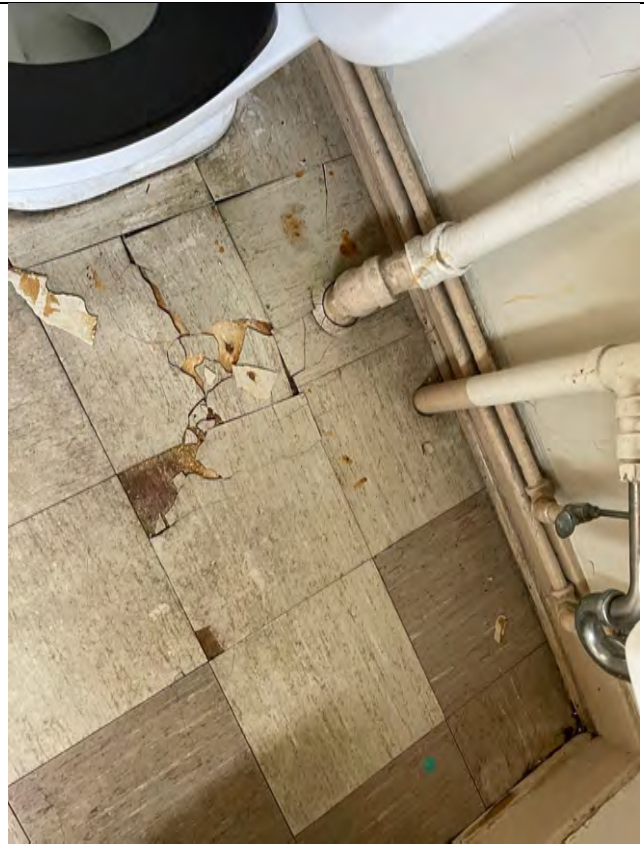
Broken bathroom tile

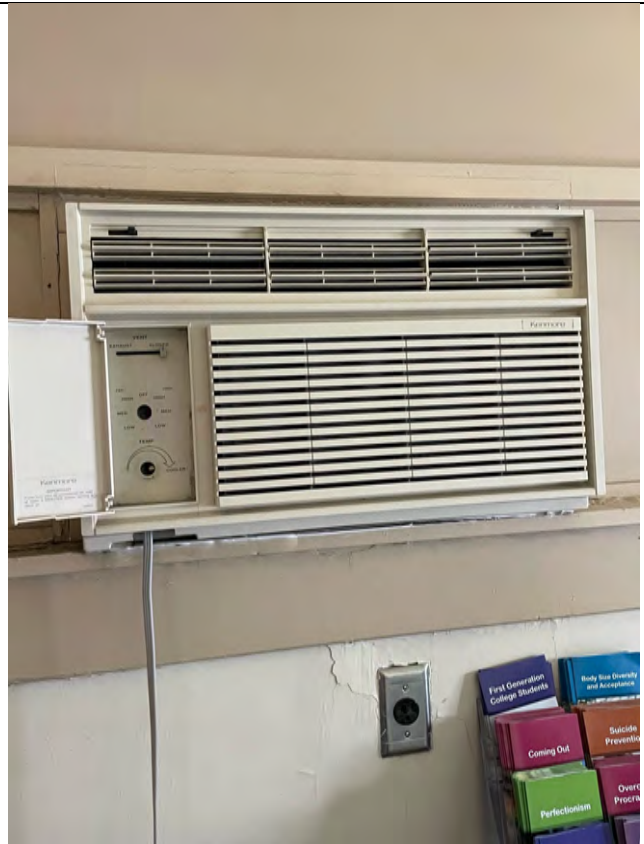
No central AC and three of their window AC units are from at least the early 90s and one of the window units doesn't have buttons so they must plug in/out for it to work. Central AC is only on the first floor, and it freezes over multiple times, so sometimes they are left without AC.
