April 9, 2024

## **Student Affairs ERM Risk Response Plans for Division Facilities**

### ***Addendum: Facility Photos and Risk Factors***

#### **TURNER STUDENT SERVICES BUILDING AND ARCADE BUILDING**

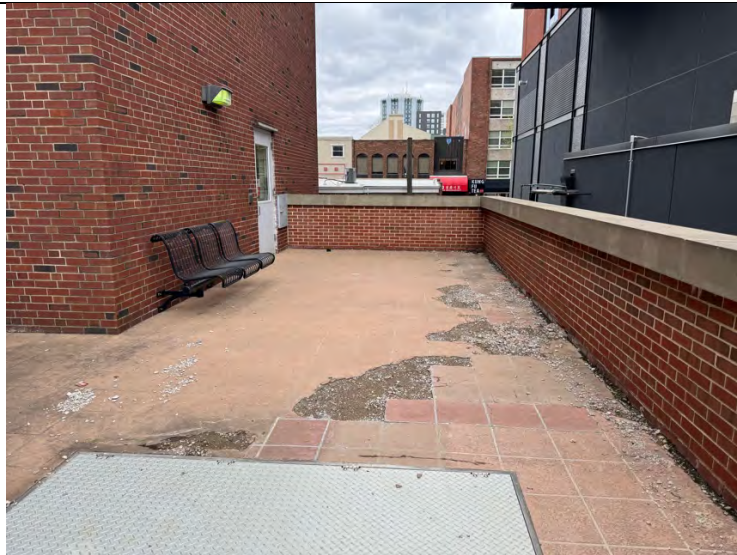
**Building:** Backside entrance for the Turner Student Services Building.

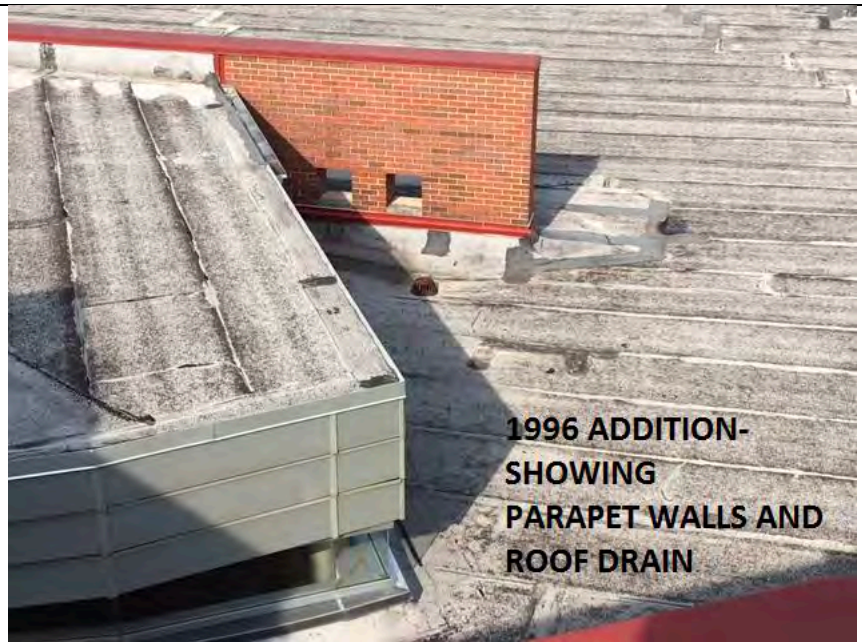
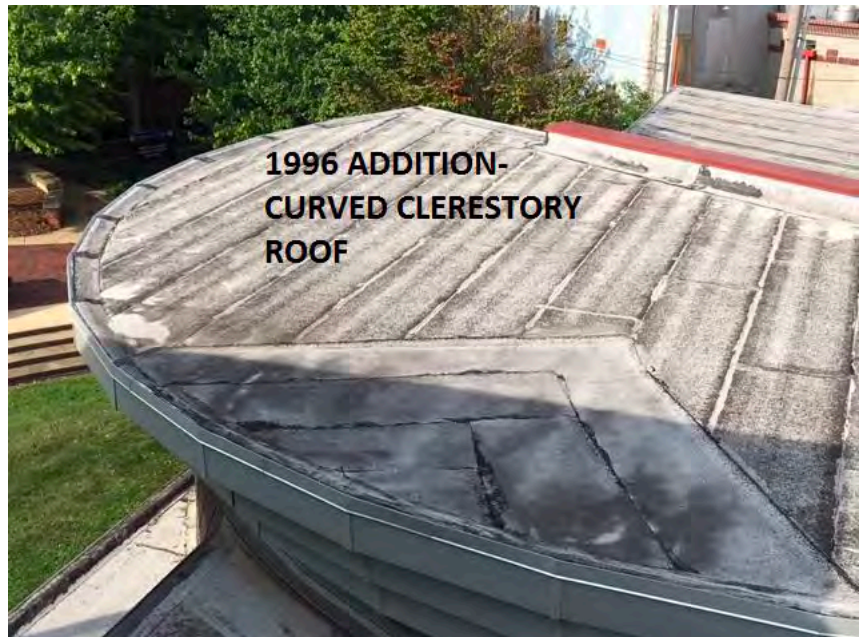
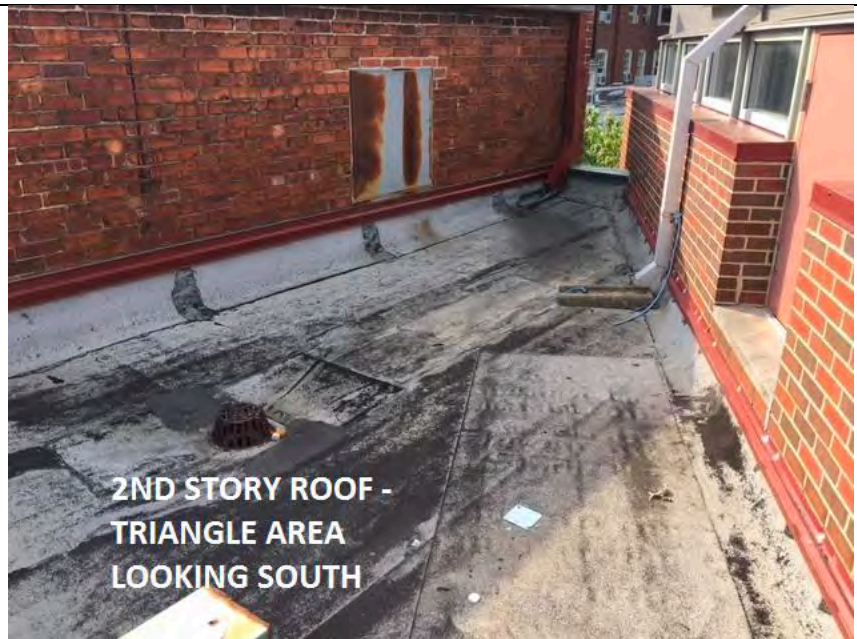
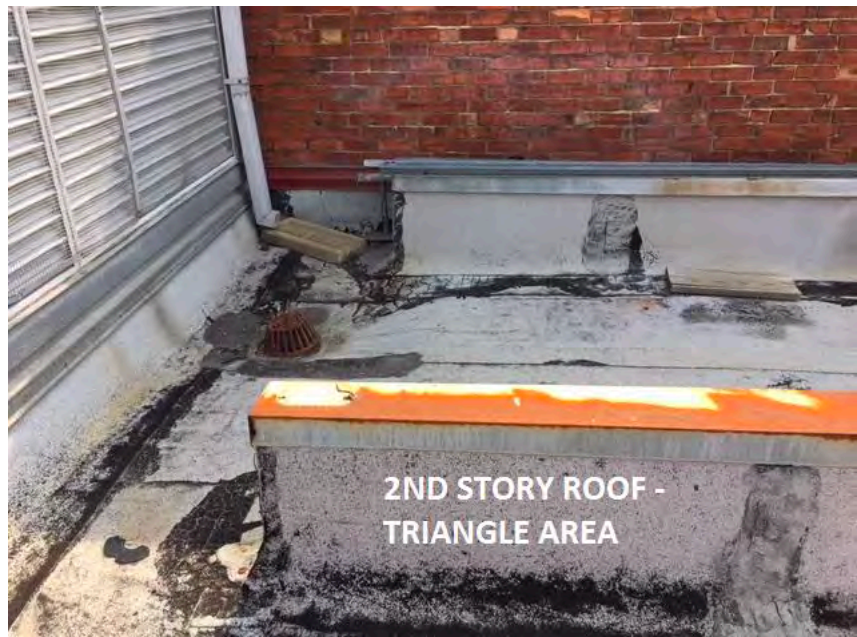
**Arcade Building: Roof**

**Arcade Building:** There is water damage in the small conference room and a couple of offices. The roof has been leaking for a long time, but we haven't been able to get the roof replaced for reasons beyond our control (see additional roof damage photos in this table, below).

Comprehensive details are available in the *Pre-planning Report: Student Service Arcade Building - #71 Roof Replacement Project*, available on request.
